Assessing Sedimentation Issues within Aging Flood Control Dams, Oklahoma

Research Report No. 15

April 2000

A preliminary report prepared for the USDA-NRCS, Stillwater, OK

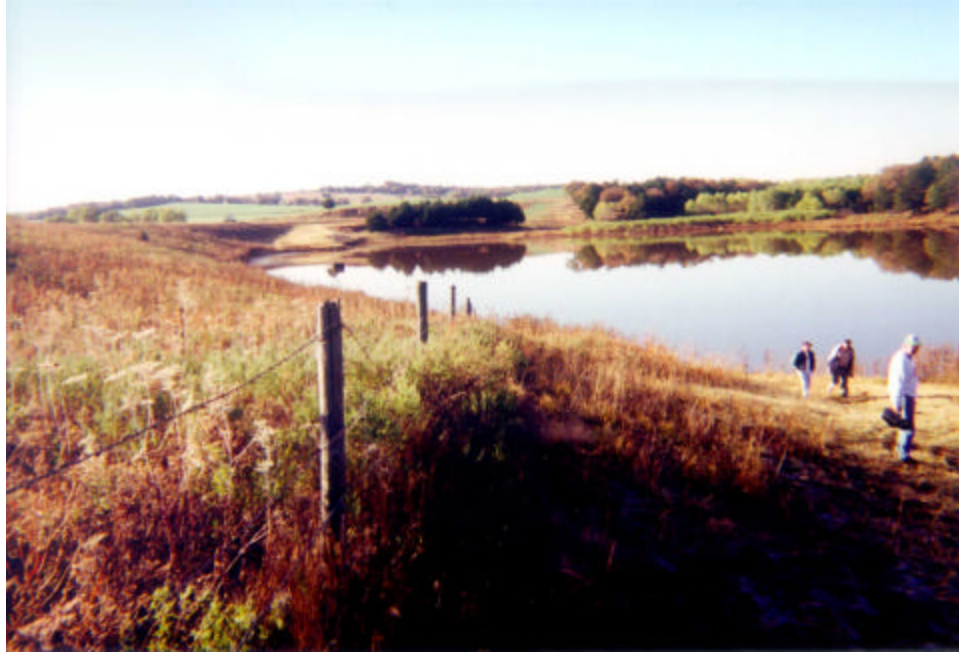
Figure 2-1. Photograph of Sugar Creek #12 looking directly south showing earthen embankment on left, spillway channel in far distance, and reservoir (November 1999).

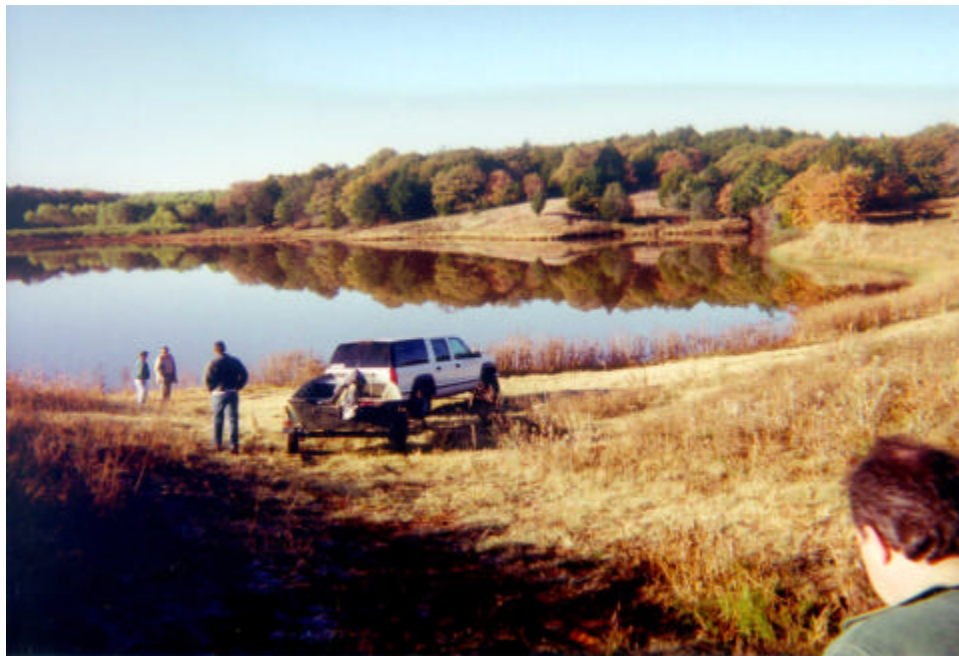
Figure 2-2. Photograph of Sugar Creek #12 looking toward the southwest showing the reservoir and the main tributary on right.

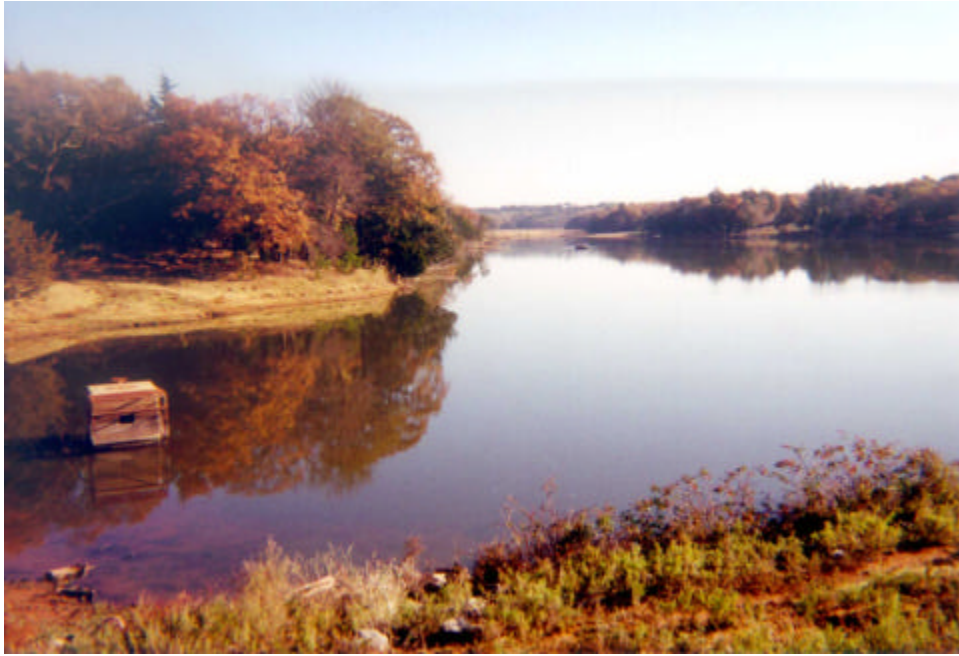
Figure 2-4. Photograph of Sugar Creek #14 looking northeast from the embankment showing reservoir, primary spillway drain on left, and main tributary source in far distance (November 1999).

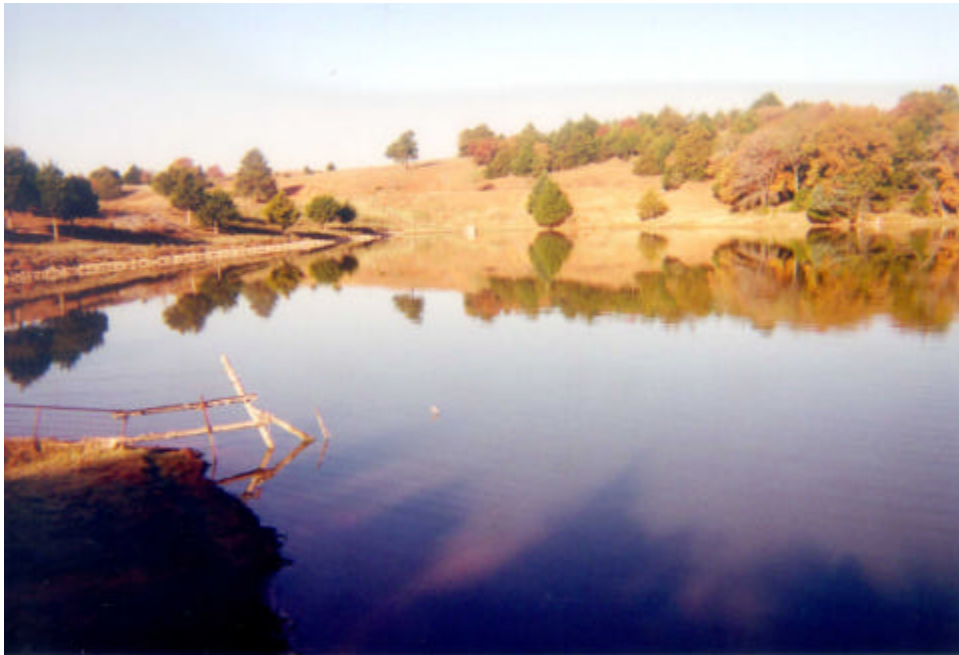
Figure 2-5. Photograph of Sugar Creek #14 looking directly west showing reservoir, earthen embankment of left, and primary spillway drain in far distance (November 1999).

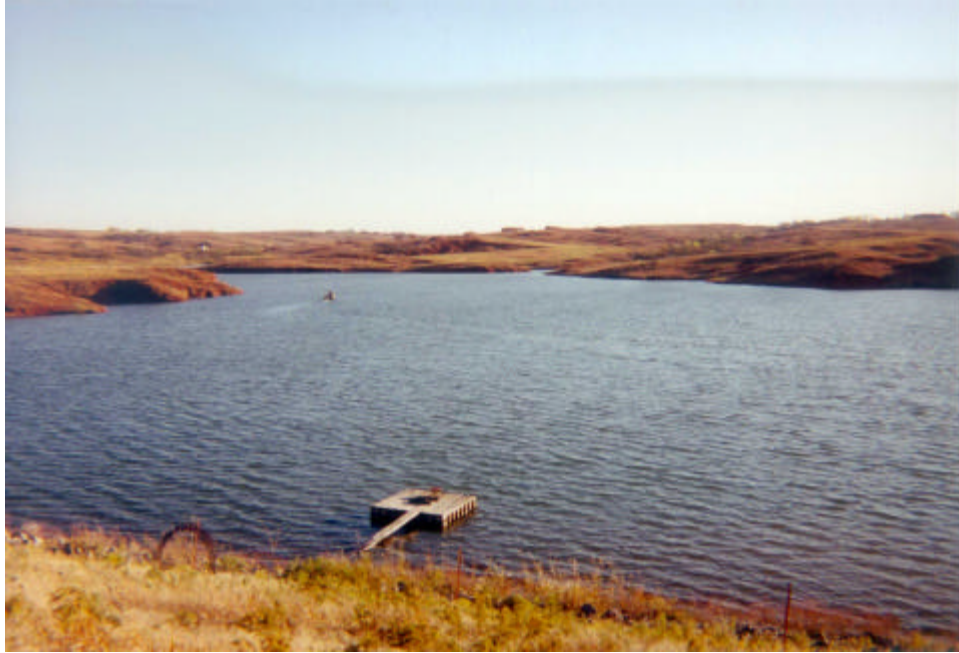
Figure 2-7. Photograph of Sergeant Major #4 looking almost directly south from the embankment showing reservoir, primary spillway drain in foreground, and the vessel used during seismic surveying in the distance (November 1999).

Sergeant Major #4 is located near Cheyenne, OK and was constructed in 1955. It is a moderately sized structure, covering an area of about 35 acres (Figures 2-7, 2-8, and 2-9), and has an upstream drainage area of 3,735 acres. This site was chosen for investigation because it has become the sole municipal source of water for the town of Cheyenne and preserving water quality is a major concern. At least three surface water sources as well as some underground springs feed the lake. Water depth ranges from 2 to 10 m, and near-vertical banks of terrigenous siliclastic rocks characterize the lake boundary. Some exposed salt deposits (primarily gypsum) also occur within the watershed. Access to the site for small vessels is good.

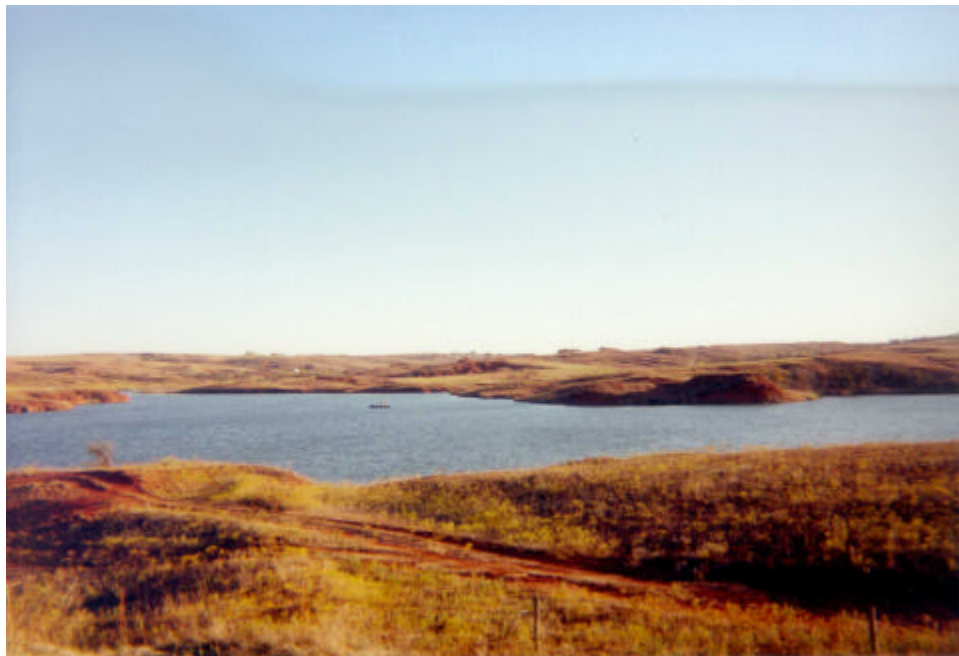
Figure 2-8. Photograph of Sergeant Major #4 looking southeast from access road showing the reservoir and the vessel used during seismic surveying in the distance (November 1999).

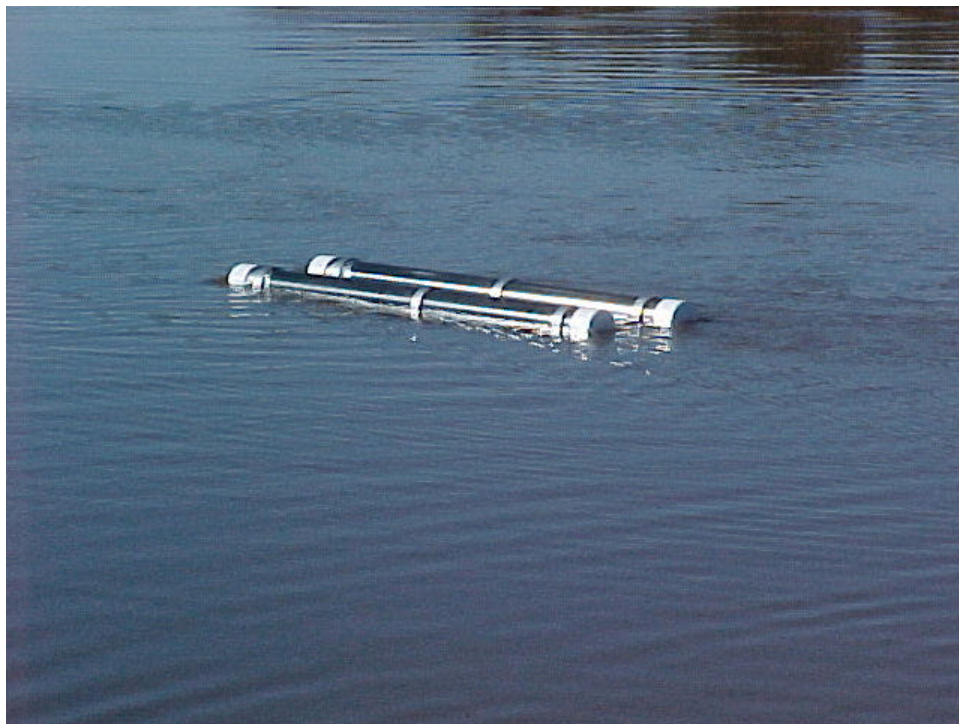
Figure 3-2. Photograph of the catamaran being towed by the vessel. The catamaran is about 7 meters from the vessel, and it is moving toward the left (taken at Sugar Creek #12, November 1999).

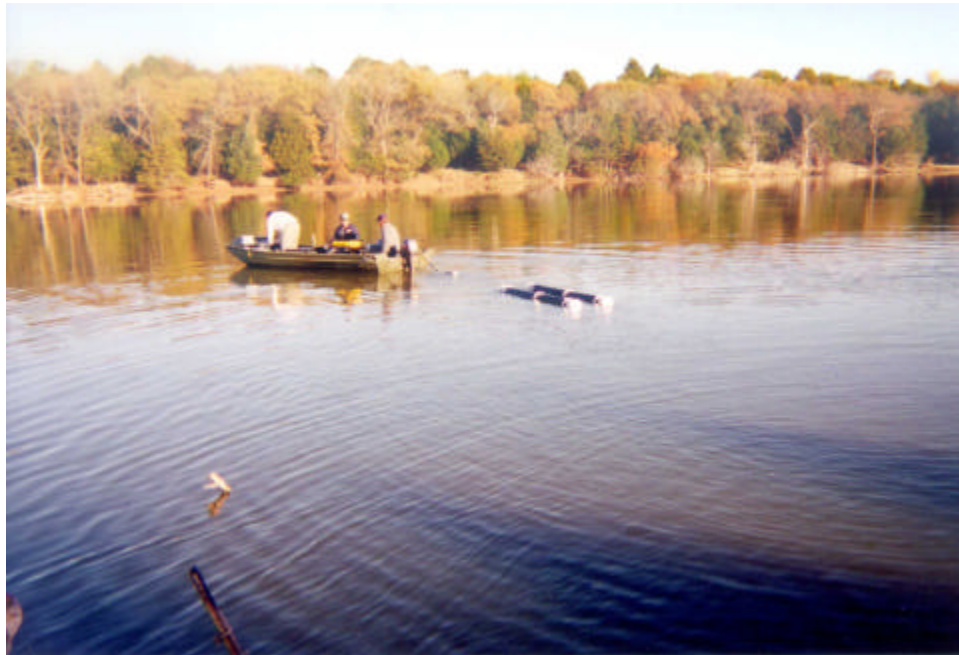
Figure 3-4. Photograph of general operating procedure for the seismic surveying and the number of personnel required (taken at Sugar Creek #14, November 1999).

All equipment was placed onto a 16-ft aluminum boat (Figure 3-4). This included signal processor, oscilloscope, gray scale recorder, DAT tape recorder, and boomer power unit. In addition, a laptop computer was used to log positioning data from a military-grade GPS receiver. A 5.8 kW generator supplied 220 V power to the boomer, and a 2.8 kW generator supplied a clean power source to all other electronic equipment. Three people typically were on the vessel: one to operate the boat and to monitor the position of the catamaran, one to operate the positioning system, and one to operate the seismic equipment.

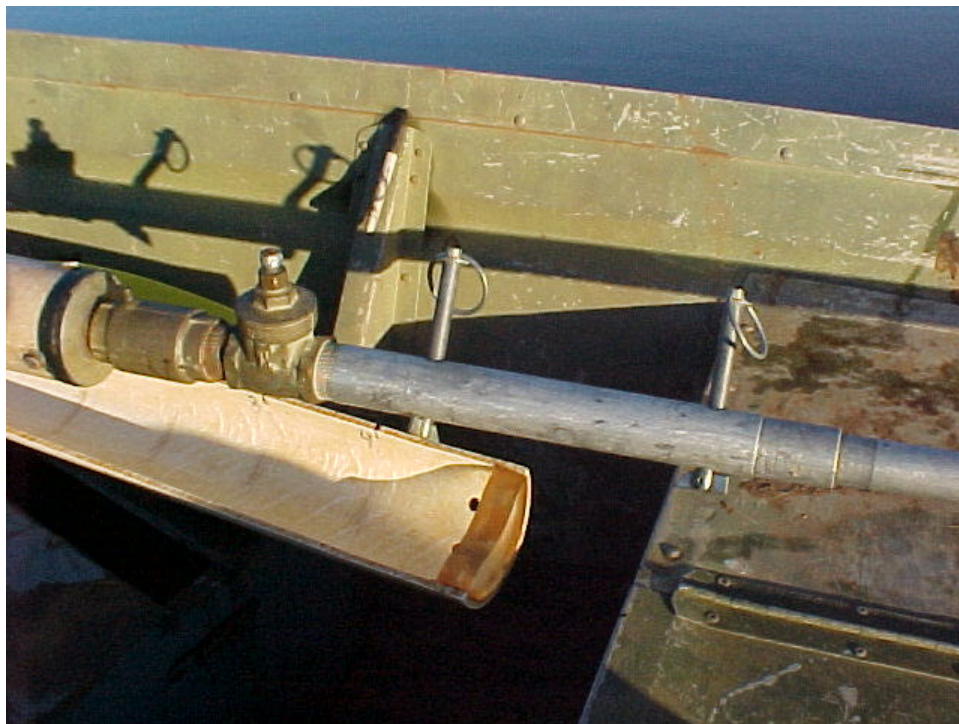
Figure 4-2. Photograph of the sediment coring tube used to obtain sediment samples and the ruled sediment core catcher (taken at Sugar Creek #12, October 1999). Also shown is the aluminum extension necessary to obtain deep-water samples.

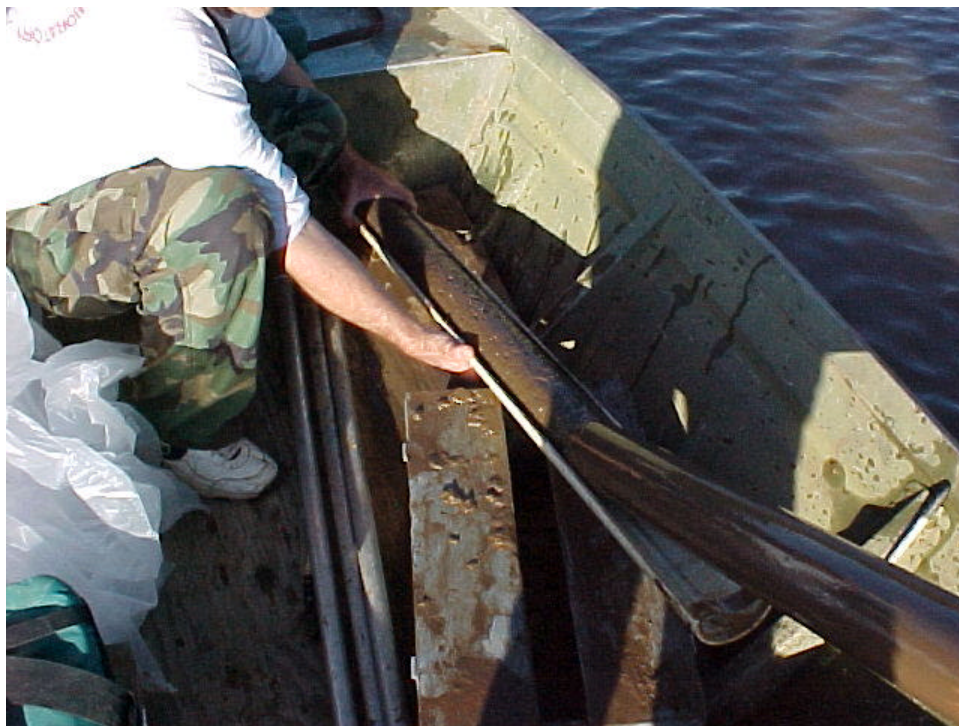
Figure 4-3. Photograph of the sediment core being extruded into core catcher (taken at Sugar Creek #12, October 1999). Core is extruded by tipping core and shaking out contents.

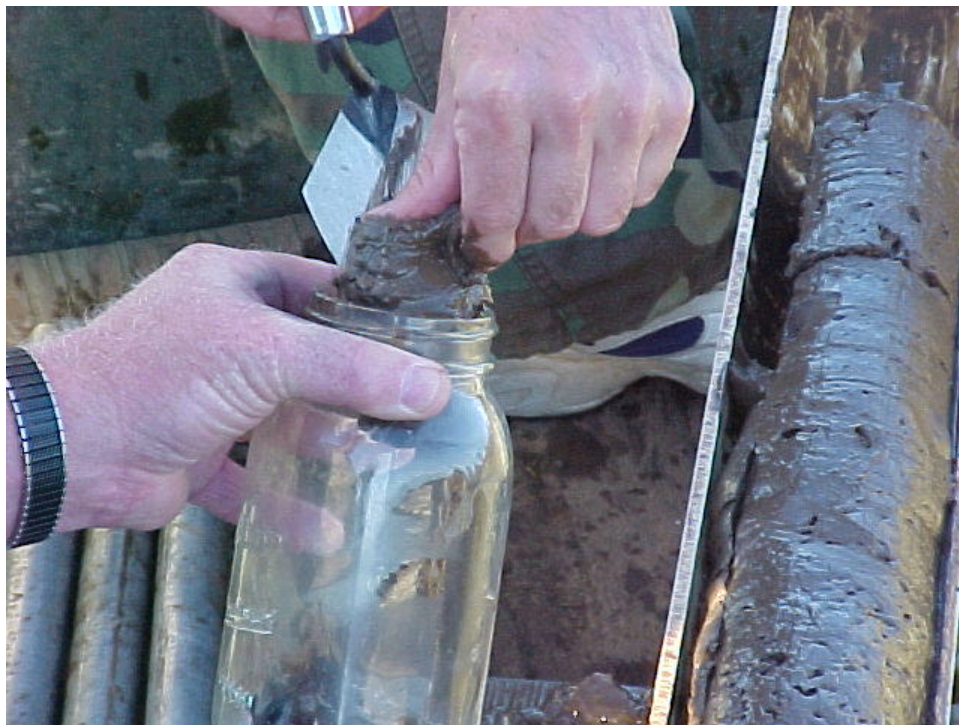
Figure 4-4. Photograph of the sediment from core being placed into sample bottles for later analysis (taken at Sugar Creek #12, October 1999).
